# PHYSICAL & ELECTRONIC SECURITY GAP ASSESSMENT

Critical Infrastructure Perimeter / Access Corridor

*Framework: CPTED • NERC CIP-014 • Critical Infrastructure Protection Best Practices*

**Prepared: Aug 1, 2026 – By Msc. Pedro Barrueco Perez**  
*Based on visual/photographic review and publicly available security standards*

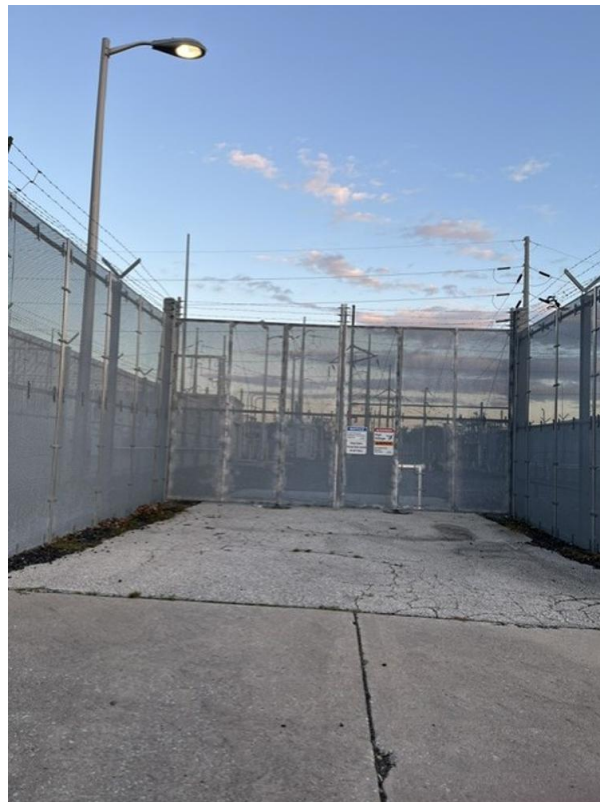
The photograph shows a fenced, mesh-screened access corridor terminating at a gated entry to what appears to be an electrical substation or comparable critical infrastructure facility. A single street-light luminaire, chain-link fencing with barbed-wire outriggers, privacy mesh, and a small warning placard are visible. No cameras, intrusion detection, vehicle barriers, or reinforced signage are visible in the frame.

Overall current-state rating: WEAK. Baseline deterrence (fencing, barbed wire, some lighting) is present, but detection, verification, delay-in-depth, and response capability are effectively absent from what is visible.

| CPTED Principle | Observed Condition | Identified Gap | Recommendation |
|---|---|---|---|
| Natural Surveillance | Privacy mesh blocks sightlines in both directions; single light fixture creates high-contrast shadow zones near the gate and far fence line. | No informal “eyes on the corridor” from outside; blind approach to the gate; light/dark contrast aids concealment rather than deterring it. | Add secondary/motion-activated lighting at the gate; consider mirrors at blind corners; evaluate mesh height/placement vs. sightline needs. |
| Natural Access Control | Single vehicle/pedestrian gate secured with what appears to be a manual chain/padlock; no visible card reader, keypad, or intercom. | No audit trail of entries/exits; no way to verify identity remotely before granting access; single point of failure if lock is defeated. | Upgrade to electronic access control (card/PIN/biometric) with logging; add an intercom/video call point for identity verification. |
| Territorial Reinforcement | Only small placards mounted on the gate itself; no perimeter-length signage. | Insufficient signaling of ownership, monitoring, and consequences along the full fence run; reduces psychological deterrence for casual trespass. | Install larger, evenly spaced signage along the entire perimeter: no trespassing, video surveillance in use, electrical hazard, and owner/operator identification. |
| Maintenance (“Image & Milieu”) | Cracked and patched concrete/asphalt pavement visible in the foreground. | Visible deferred maintenance is a classic broken-windows signal that can lower perceived guardianship and invite testing of defenses. | Repair pavement and maintain visible upkeep as part of routine site management; treat visible condition as a security signal, not only a safety one. |

| CIP-014 Element | Standard's Intent | Observed Gap (from photo) | Recommendation |
|---|---|---|---|
| R4–R5: Physical Security Plan – Detection | Plans should include intrusion detection: fence sensors, video analytics, sound/gunshot detection. | No visible cameras, fence-mounted sensors, or acoustic/gunshot detection equipment. | Deploy CCTV with video analytics at the gate and along vulnerable fence spans; add fence-mounted vibration/strain sensors; evaluate acoustic gunshot detection given CIP-014's origin in a sniper attack. |
| R4–R5: Physical Security Plan – Delay (“Protection in Depth”) | Multiple layers of delay between the perimeter and critical equipment (buffer zones, secondary fencing, hardened barriers). | Only a single fence line and gate are visible; no buffer zone or secondary delay layer apparent between the corridor and the equipment yard beyond. | Introduce a buffer zone concept along the outer fence; consider a secondary interior barrier around the most critical equipment (transformers). |
| R4–R5: Vehicle/Ballistic Considerations | Post-Metcalf guidance emphasizes standoff distance, ballistic/vehicle barriers around critical equipment. | No bollards, K-rated barriers, or ballistic screening visible at the gate or along sightlines into the equipment yard. | Add vehicle barriers (bollards or crash-rated gate) at the entrance; evaluate ballistic screening/berms for line-of-sight protection of critical transformers. |

| Control Category | Current (Observed) | Target | Notes |
|---|---|---|---|
| Perimeter Fencing / Barbed Wire | 3 | 4–5 | Present but no anti-climb base treatment or vehicle barriers visible. |
| Lighting | 2 | 4–5 | Single fixture; no redundancy; strong shadow zones at gate. |

| Control Category | Current (Observed) | Target | Notes |
|---|---|---|---|
| Access Control (gate) | 1 | 4 | Appears to be manual lock only. |
| Site Maintenance / Image | 3 | 4 | Cracked pavement; otherwise tidy. |

- Add motion-activated supplemental lighting at the gate to remove shadow zones.
- Install visible CCTV (even a single wide-angle camera with recording) covering the gate and corridor.
- Add perimeter-length warning/deterrent signage, not just gate placards.

- Upgrade gate lock to an auditable electronic access control system with remote verification (intercom/video call point).
- Install fence-mounted intrusion detection (vibration/strain or fiber-optic sensing).
- Repair pavement and address other visible deferred-maintenance items.

- Evaluate and install vehicle barriers (bollards or a crash-rated gate) consistent with CIP-014 post-Metcalf guidance.
- Assess line-of-sight/ballistic exposure of critical equipment and consider screening or berms.
- Confirm and, if needed, initiate a formal CIP-014 risk assessment (R1–R3) if this facility meets applicability thresholds, including third-party verification (R2) and plan review (R6).
- Evaluate UAS/drone detection and cyber-physical (SCADA) coordination with the site's broader NERC CIP program.
